WL-TR-95-4108

**HIGH TEMPERATURES COATINGS
FOR TITANIUM ALUMINIDES**

**J. C. Schaeffer
R. L. McCarron**

**GENERAL ELECTRIC COMPANY - AIRCRAFT ENGINES
ENGINEERING MATERIALS TECHNOLOGY LABORATORIES
CINCINNATI, OHIO 45215-6301**

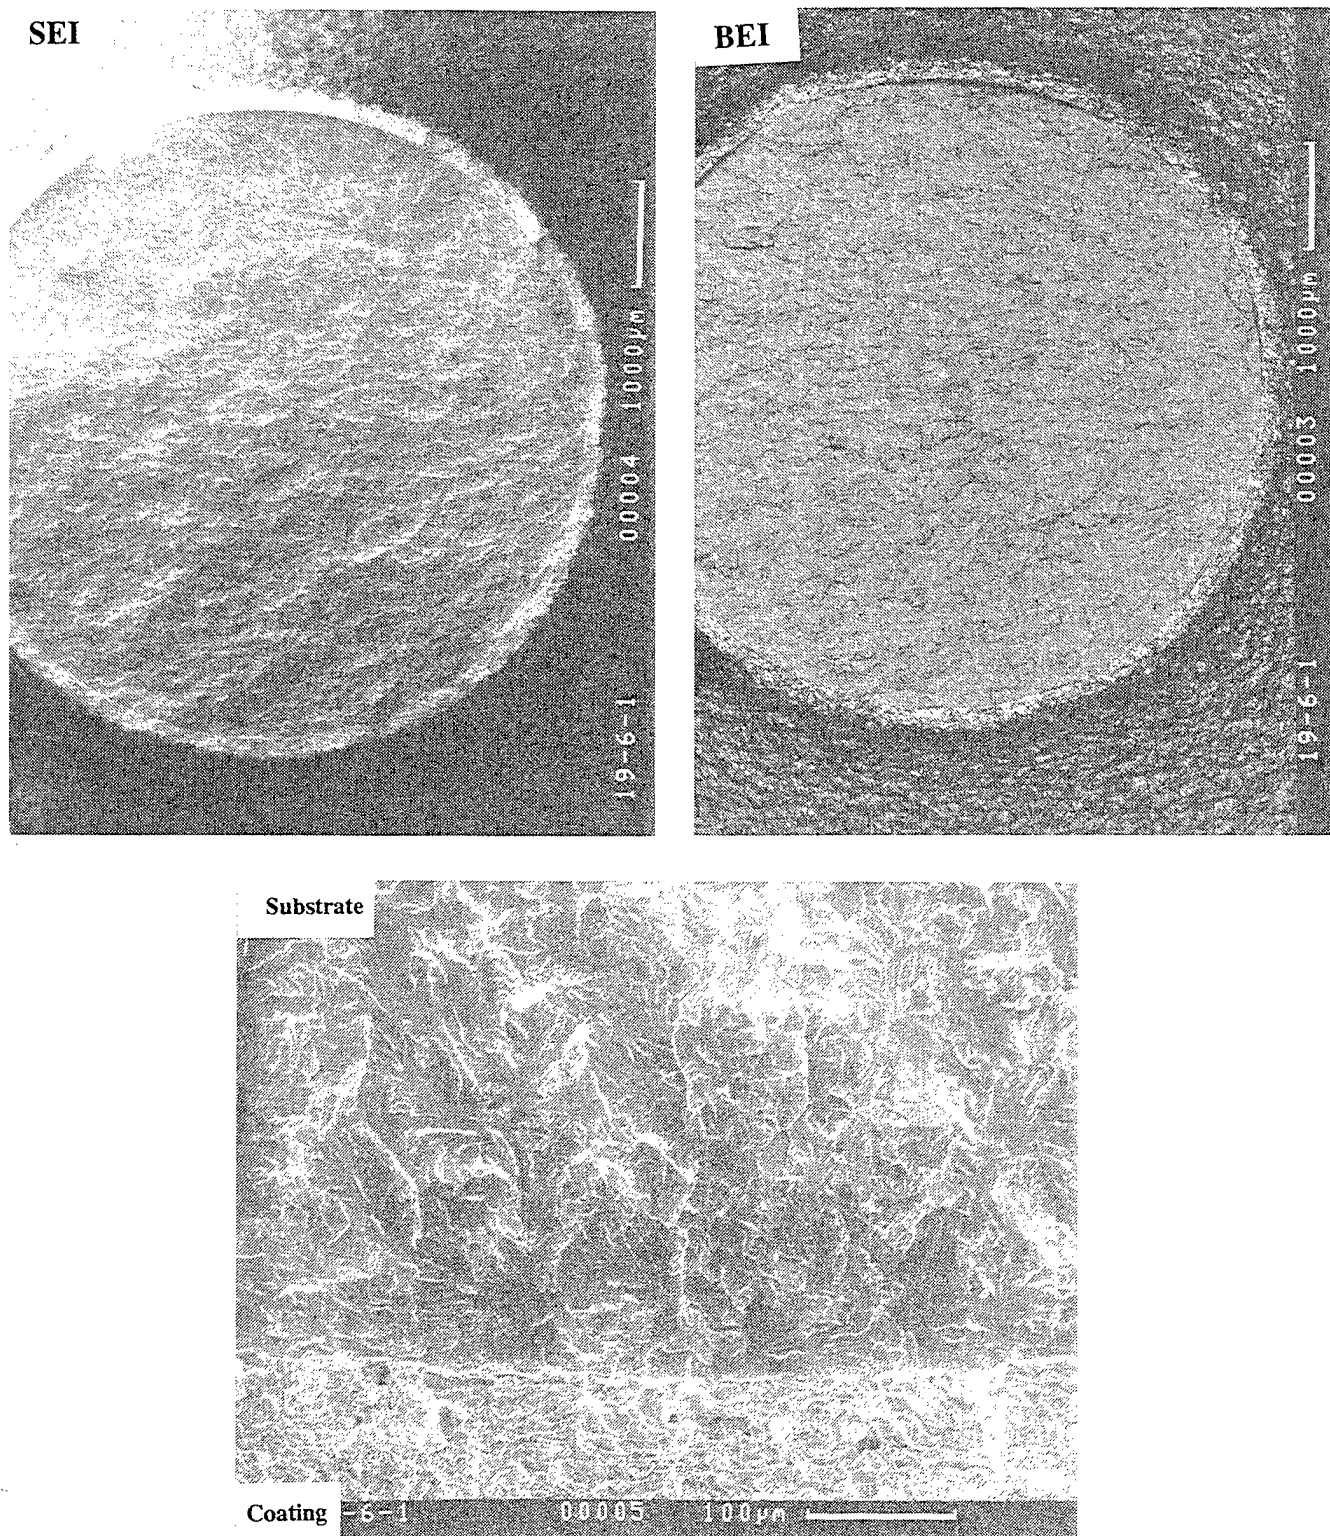
Figure 134. Micrographs showing the Alloy 718 cermet (M^3) specimen on gamma after a 750h HSSCC exposure at 1050°F/40ksi. The sample failed in the radius during the post exposure tensile test.

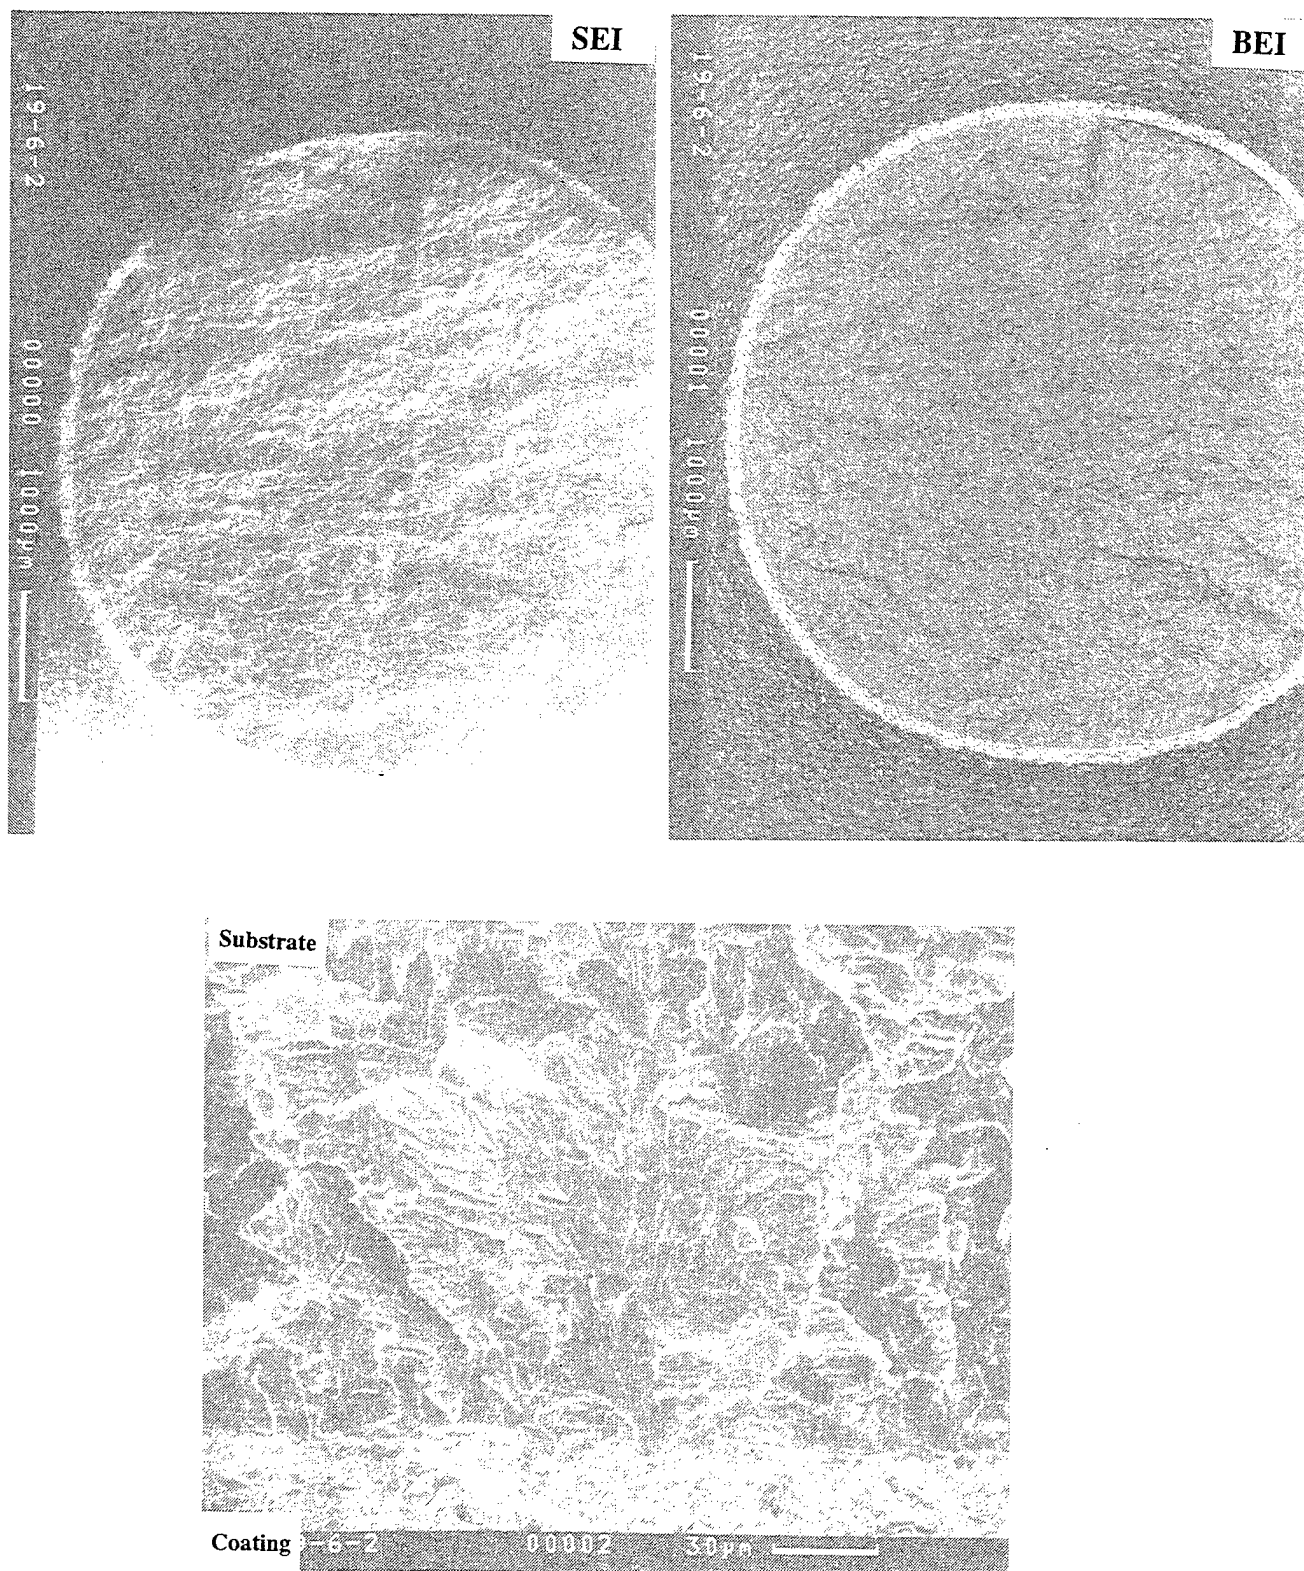
Figure 135. Micrographs showing the CoCrAlY cermet (M³) specimen on gamma after a 750h HSSCC exposure at 1050°F/40ksi. The sample failed in the radius during the post exposure tensile test.

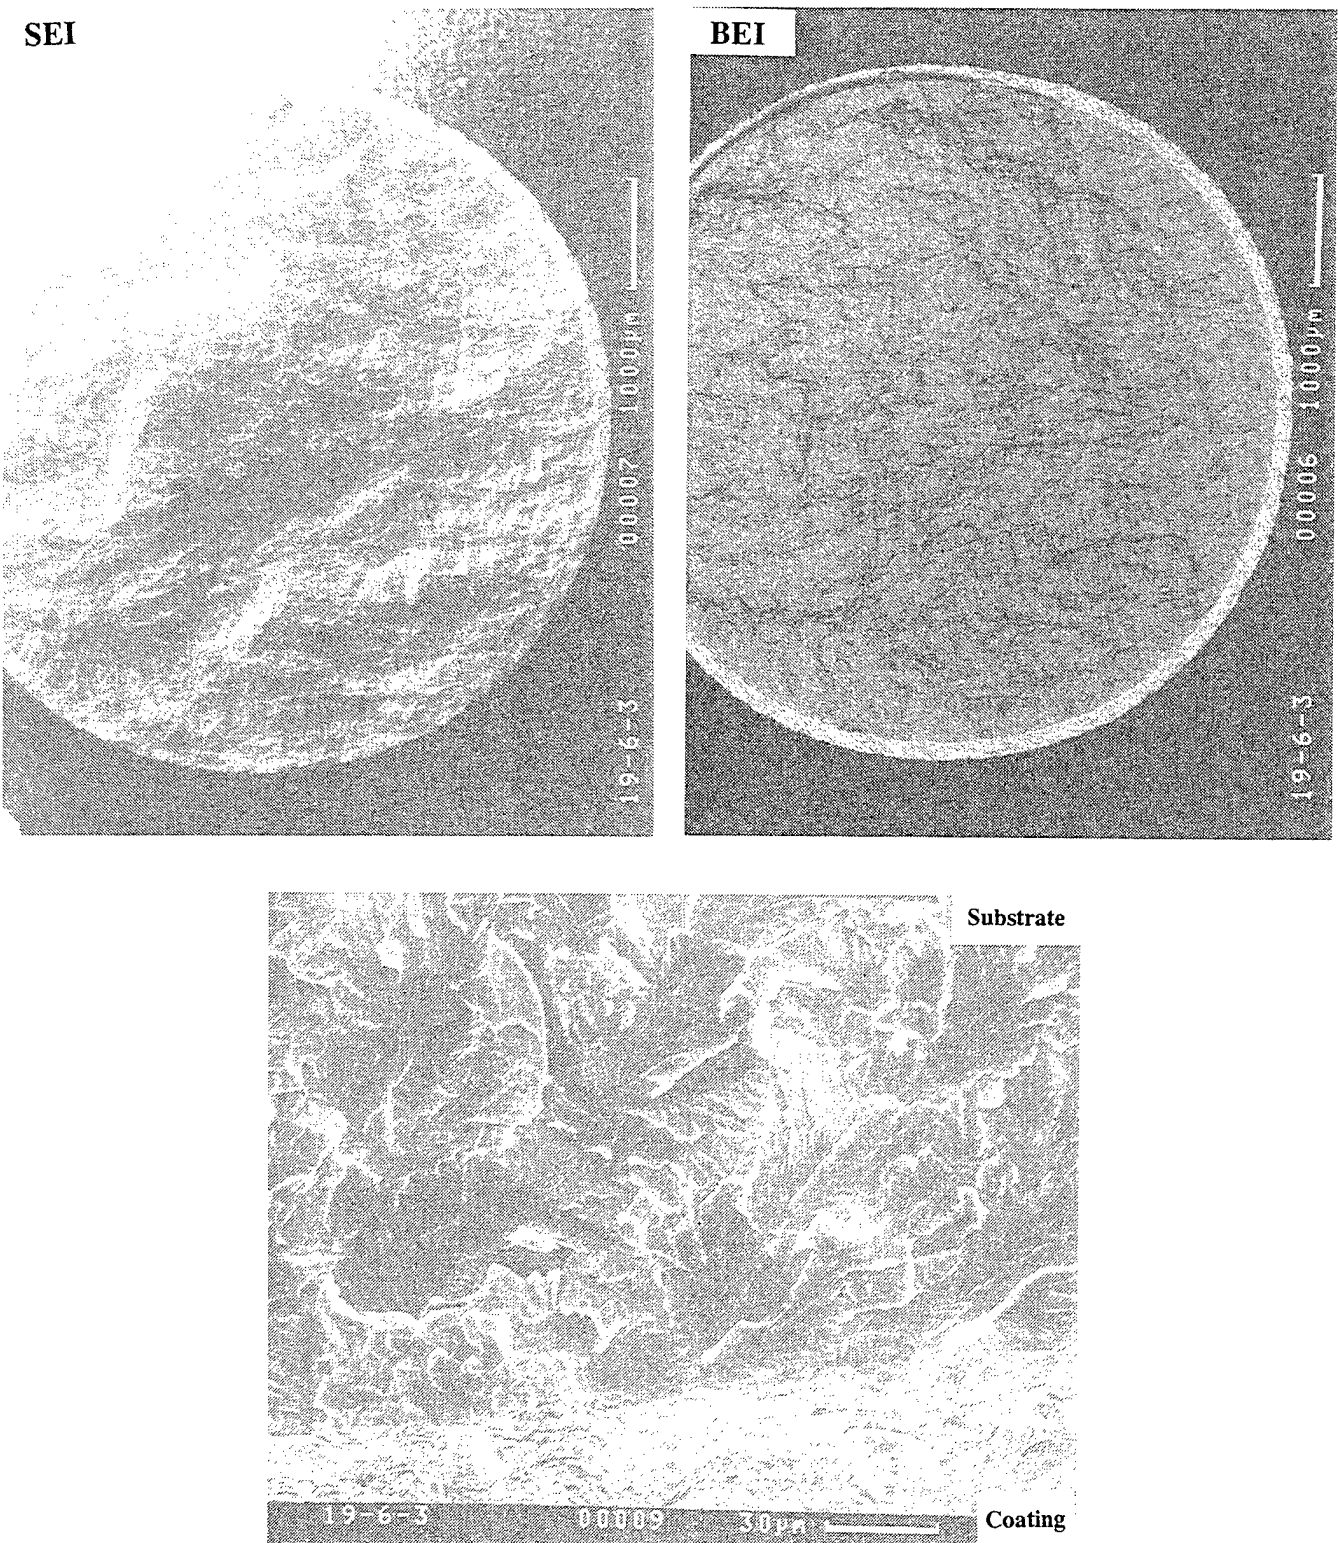
Figure 136. Micrographs showing the NiCoCrAlY cermet (M^3) specimen on gamma after a 750h HSSCC exposure at 1050°F/40ksi. The sample failed in the radius during the post exposure tensile test.

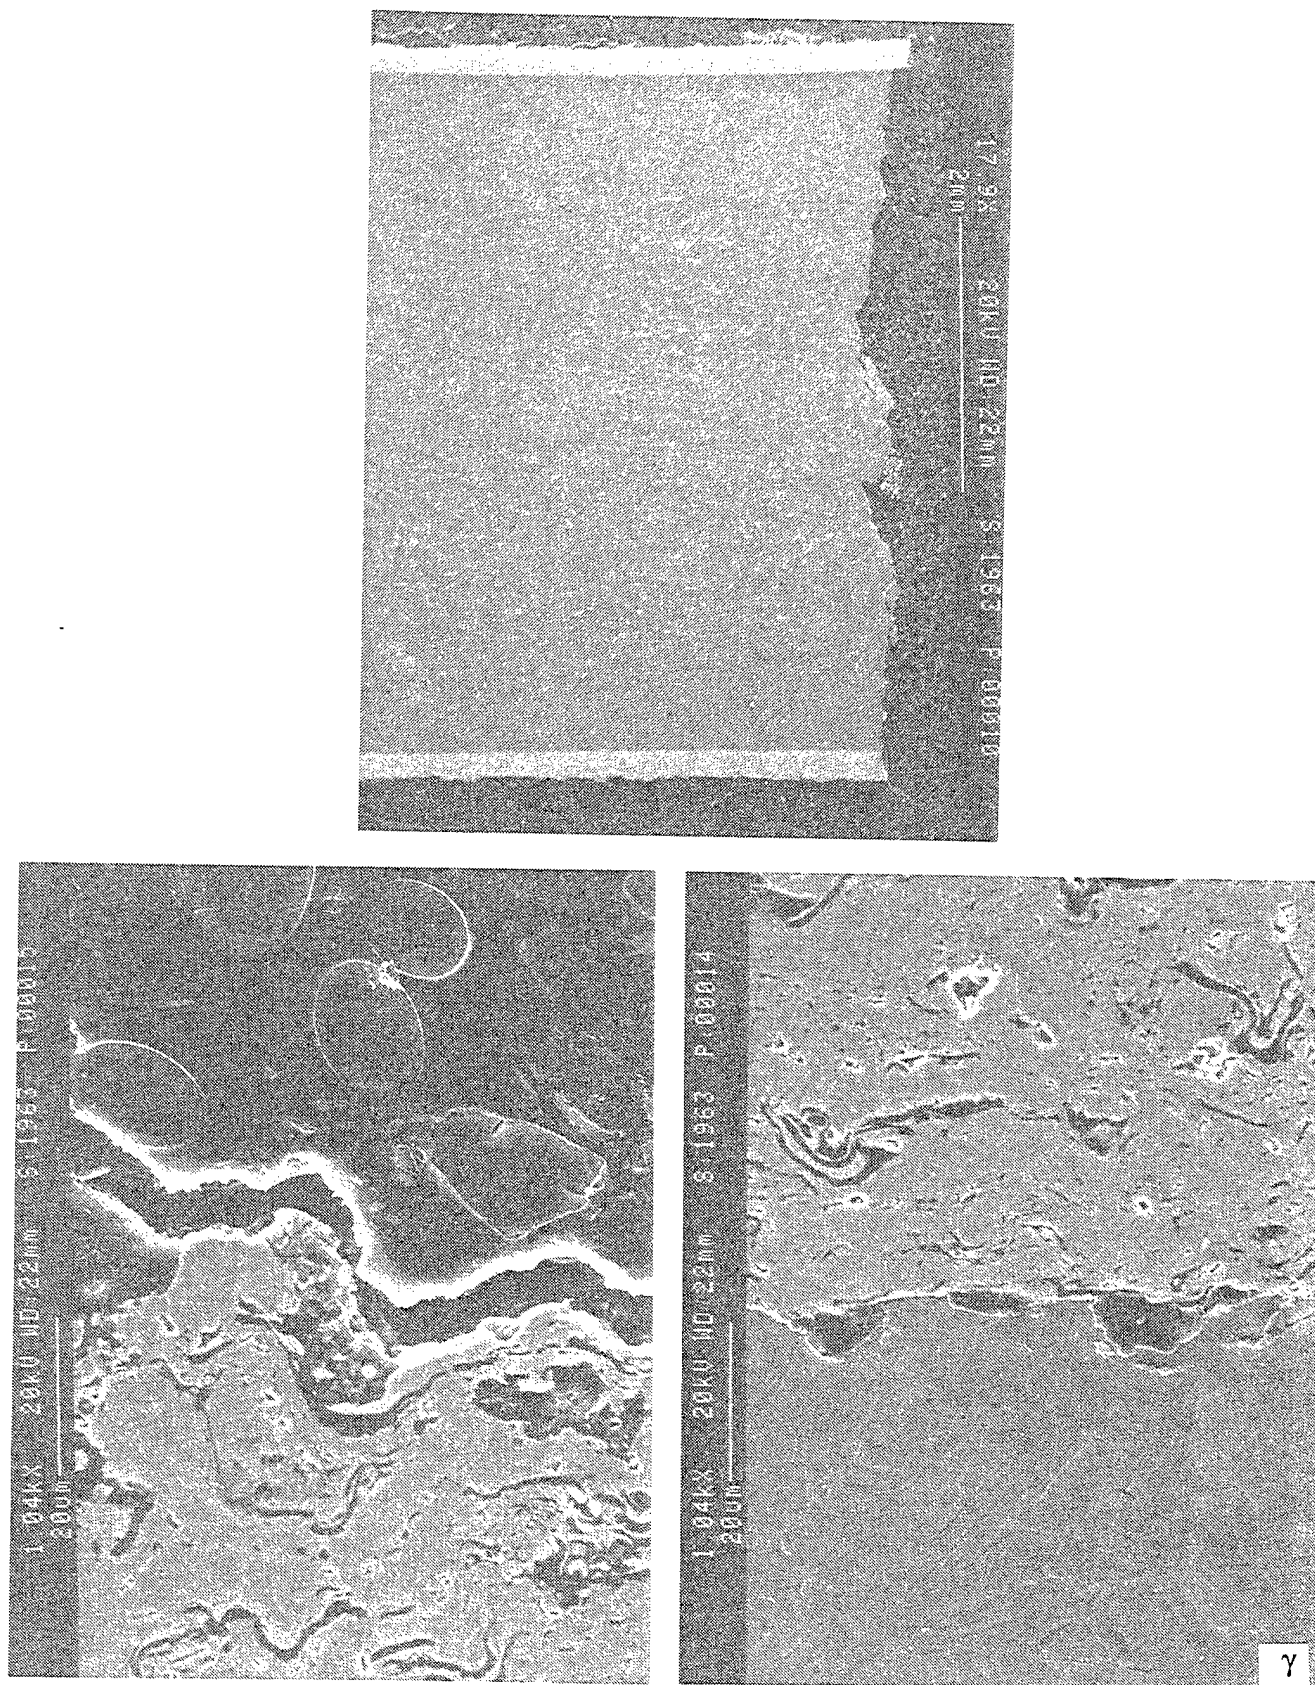
Figure 137. Micrographs showing the fractured cross section of the NiCoCrAlY composite coating on the gamma Ti-48Al-2Cr-2Nb alloy after a 1050°F/40ksi exposure with salt followed by a room temperature tensile test. The coating was adherent.

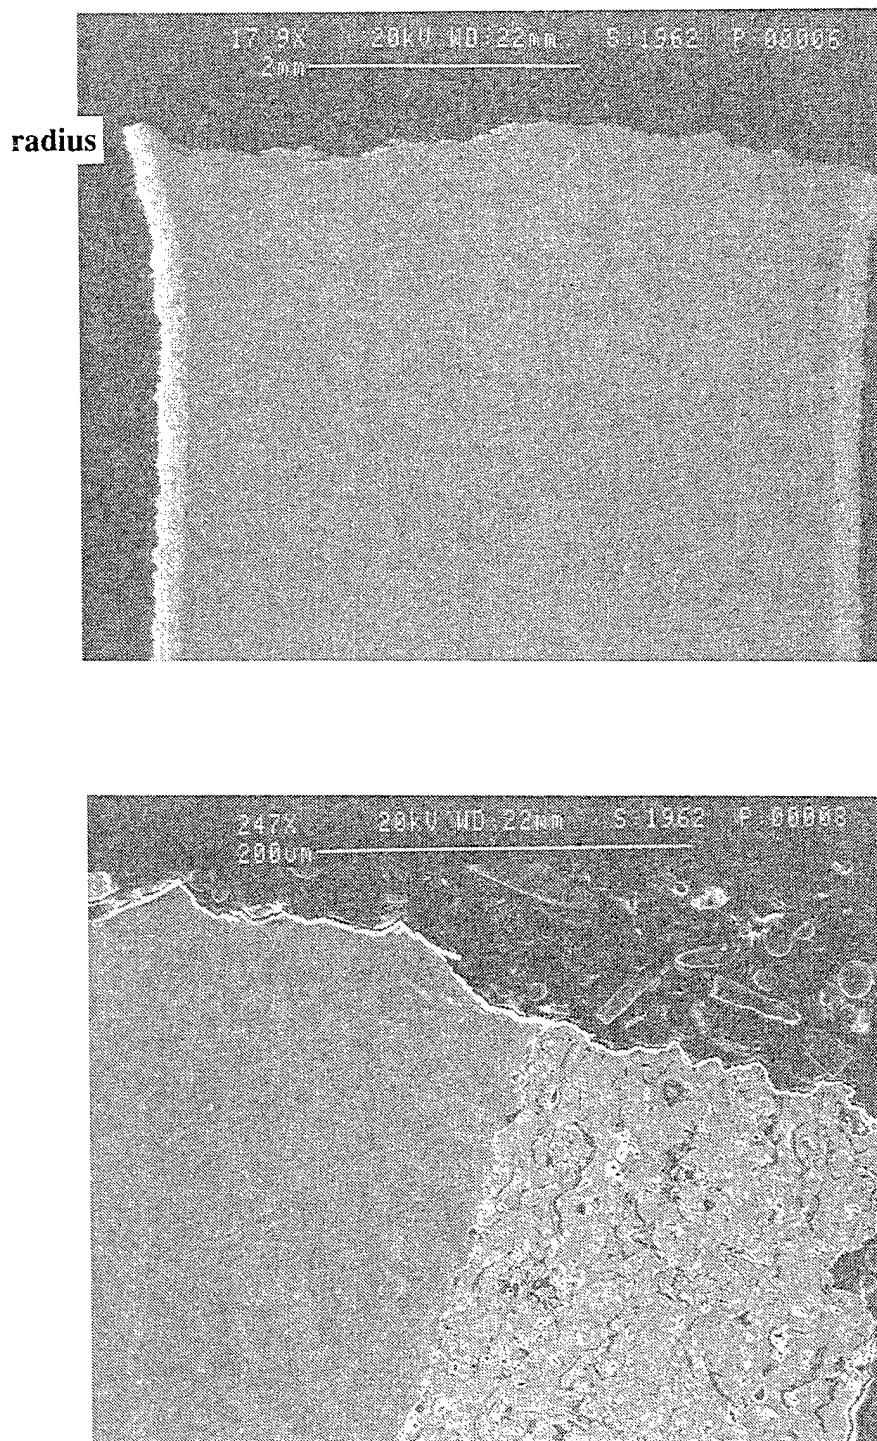
Figure 138. Micrographs showing the fractured cross section of the CoCrAlY composite coating on the gamma Ti-48Al-2Cr-2Nb alloy after a 1050°F/40ksi exposure with salt followed by a room temperature tensile test. The coating was adherent.

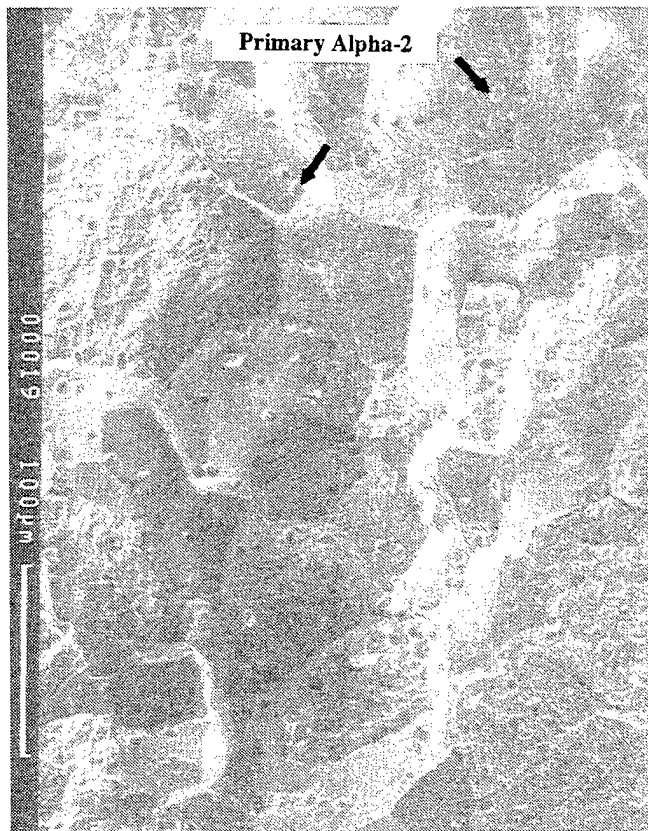
Figure 140. Micrographs of the Alloy 718 cermet (M^3)/alpha-2 specimen after 1.1h of HSSCC exposure. Large HSSCC cracks are observed throughout the cross section. The intergranular nature of the fracture cannot be overlooked.

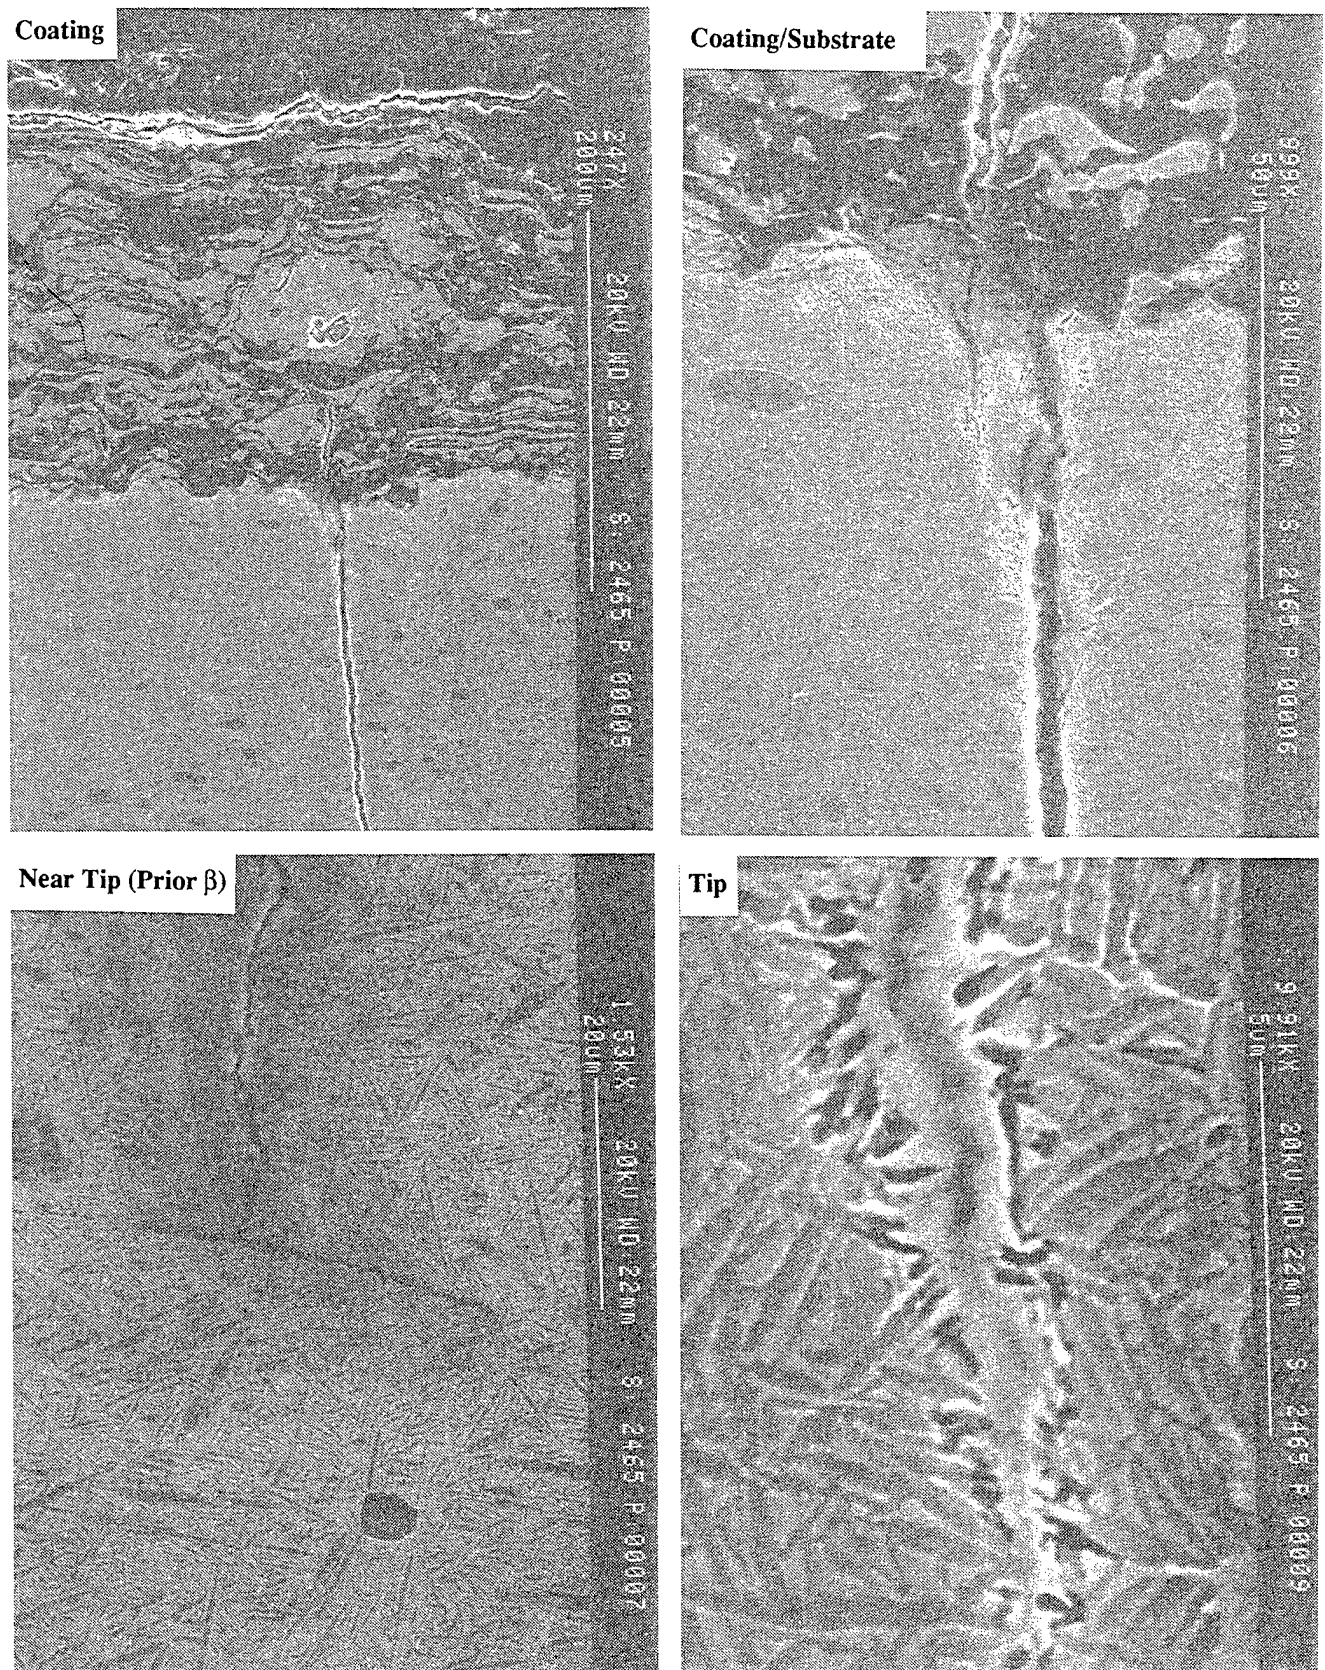
Figure 141. Micrographs of the Alloy 718 cermet (M³)/alpha-2 specimen after 1.1h of HSSCC exposure showing the morphology of the crack in the coating, at the coating/substrate interface and at the crack tip in the substrate. The crack tends to propagate down prior β grain boundaries.

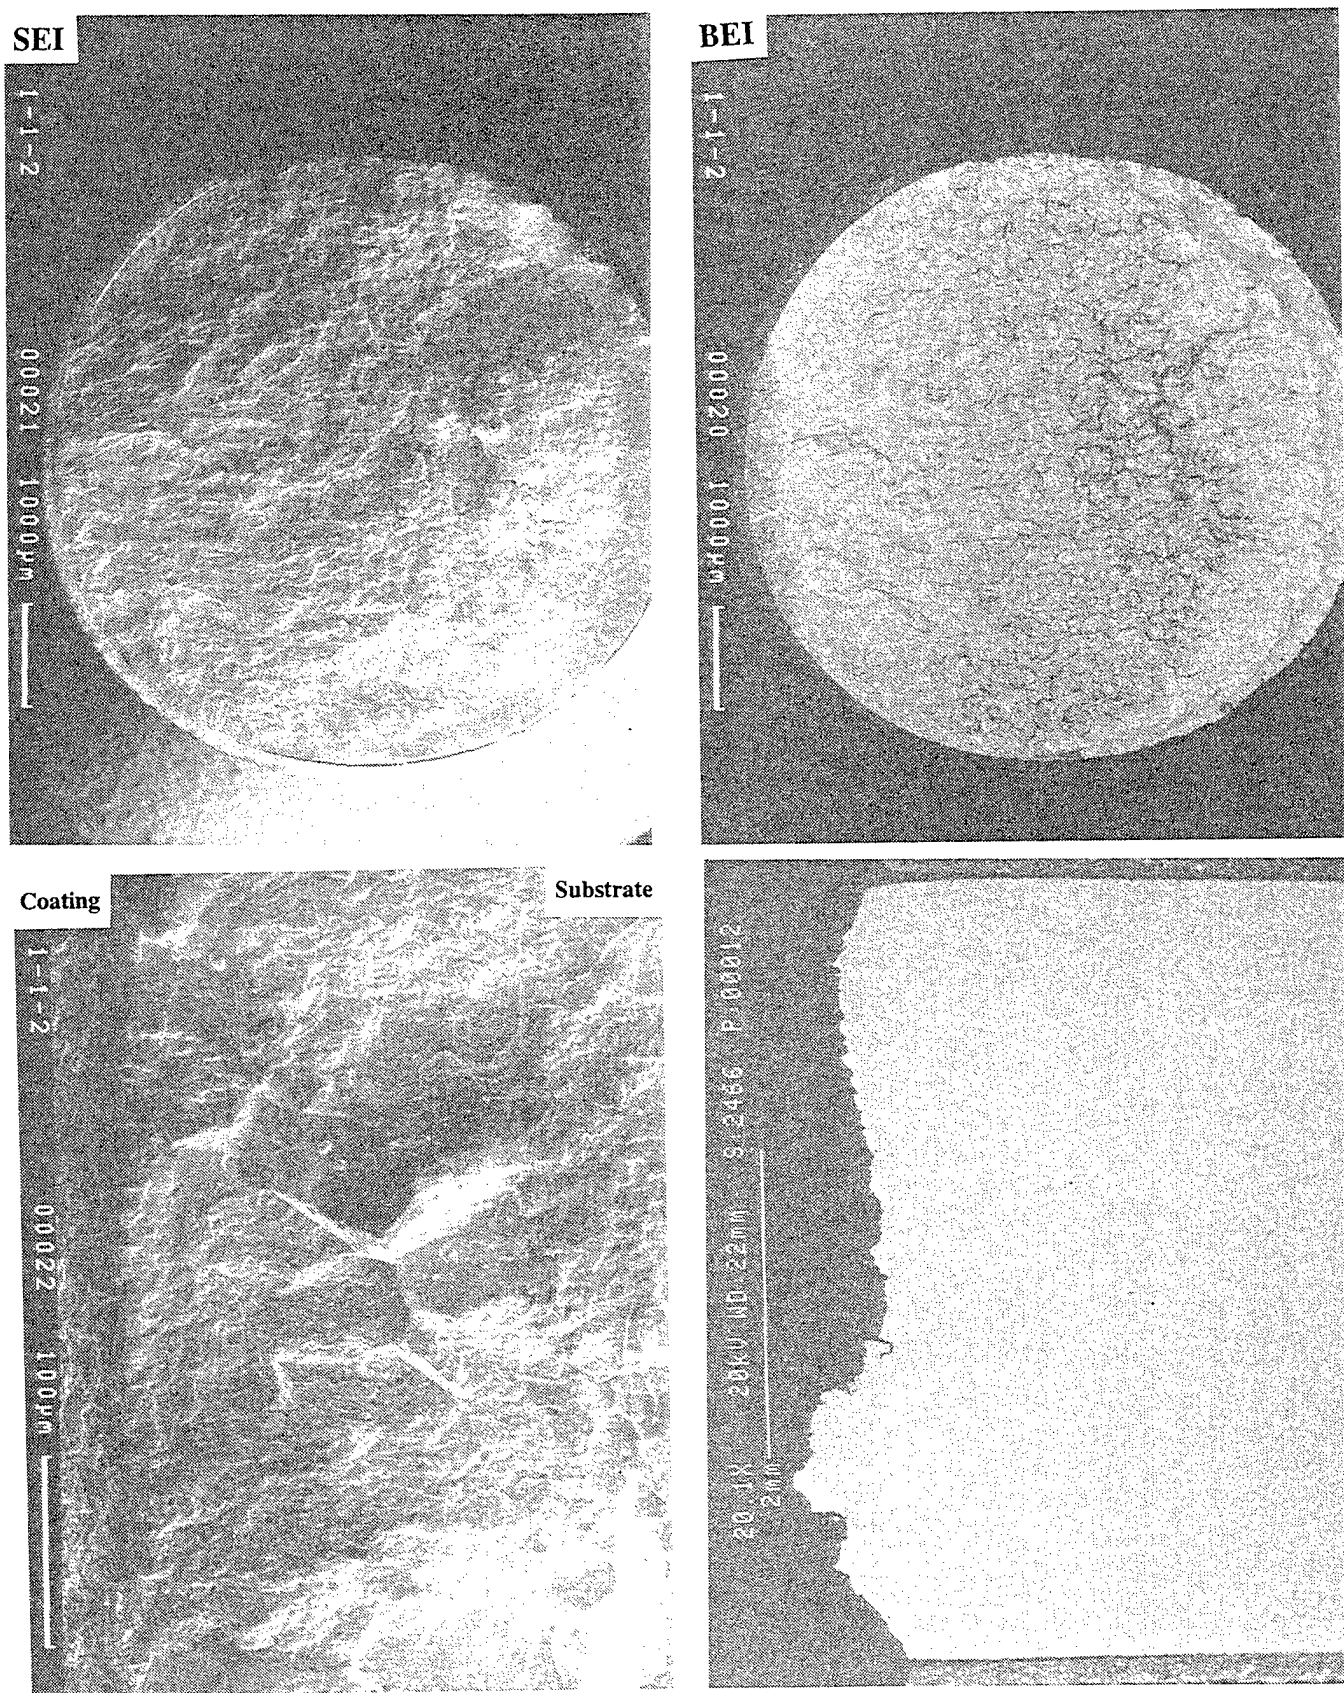
Figure 142. Micrographs showing the fracture surface of the CoCrAlY cermet (M^3)/alpha-2 coating after 62h of HSSCC exposure. The sample had a large origin that was associated with Cl.

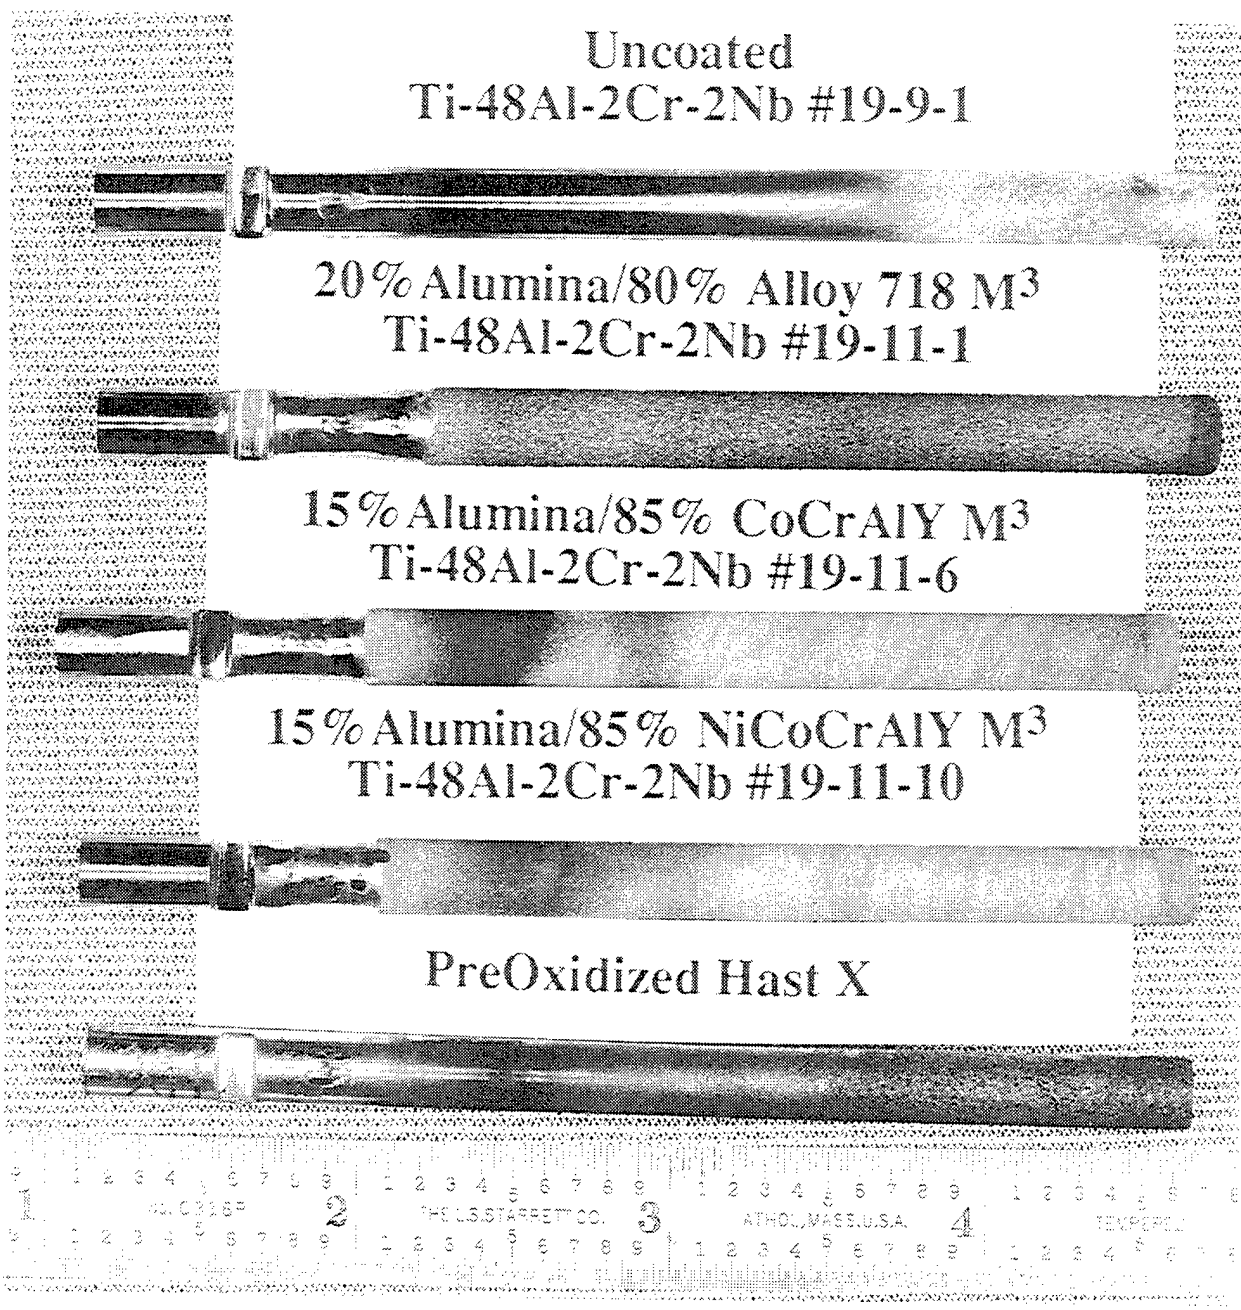
Figure 145. Color photographs showing the flame-side of coated and uncoated Ti-48Al-2Cr-2Nb gamma after 3749 cycles (625 hr) of burner rig testing using a 760°C/648°C cycle with 1ppm sea salt.

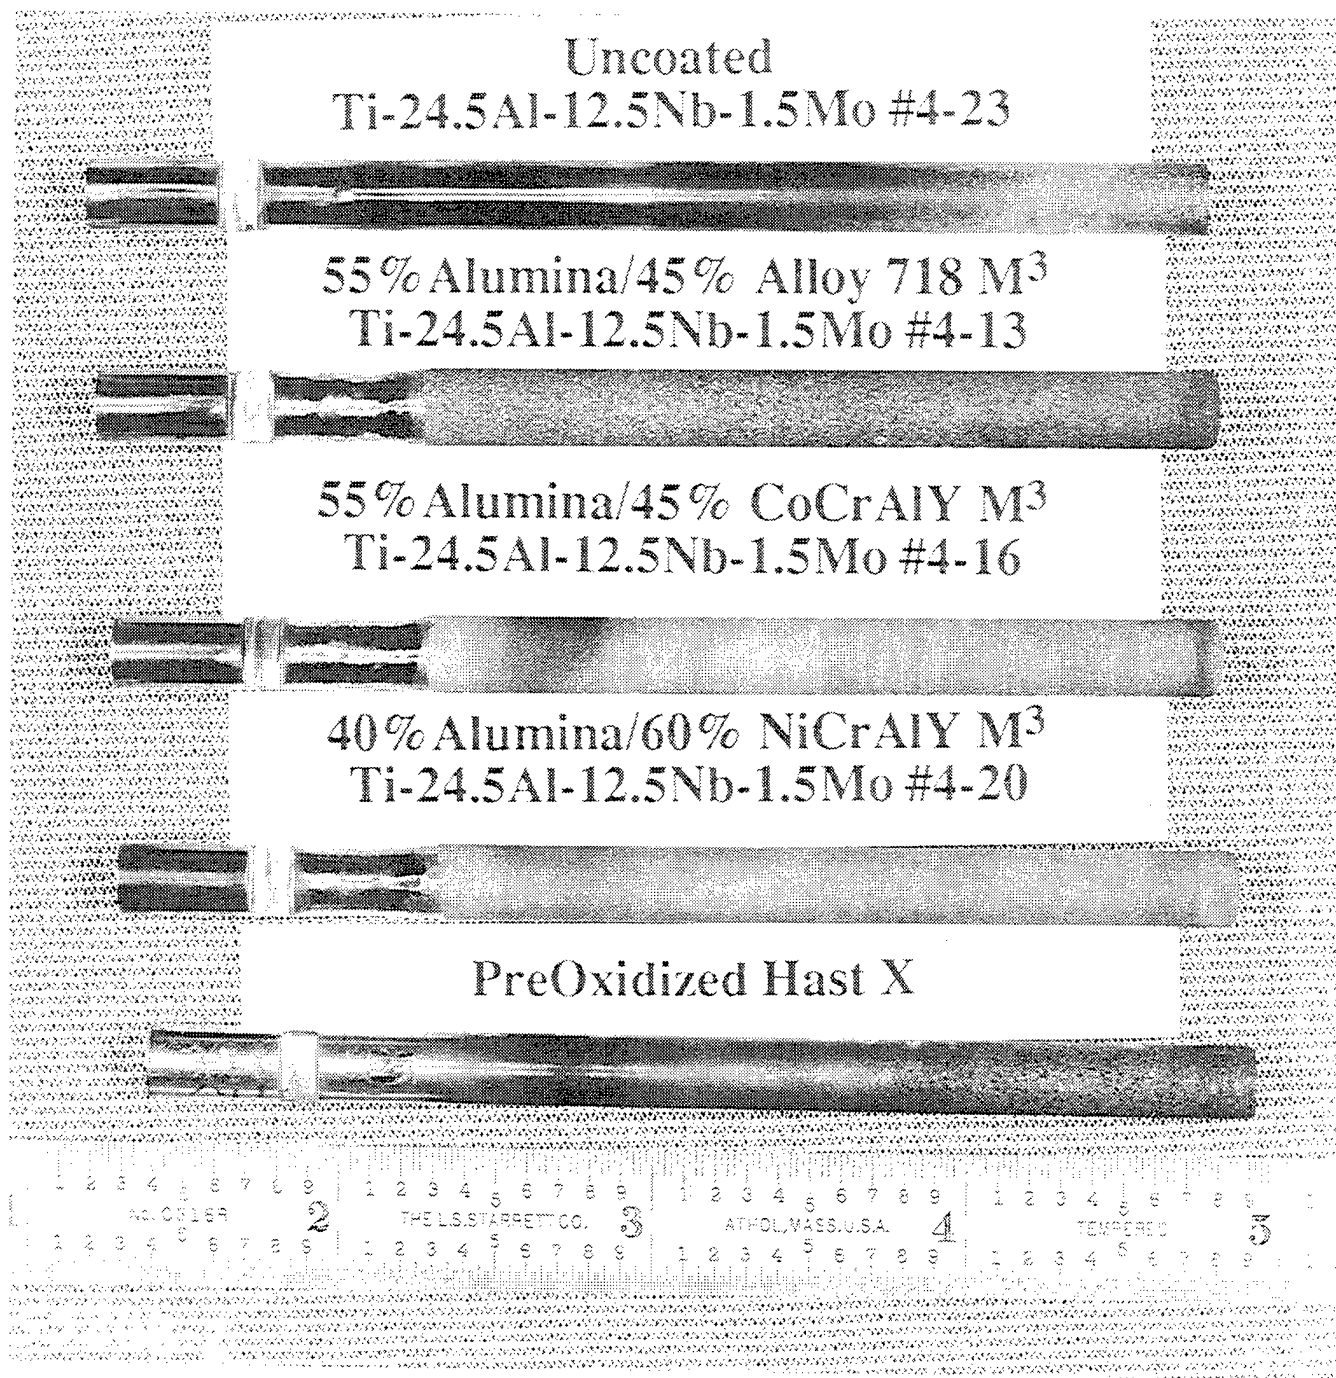
Figure 147. Color photographs showing the flame-side of coated and uncoated Ti-24.5Al-12.5Nb-1.5Mo alpha-2 after 3749 cycles (625 hr) of burner rig testing using a 760°C/648°C cycle with 1ppm sea salt.

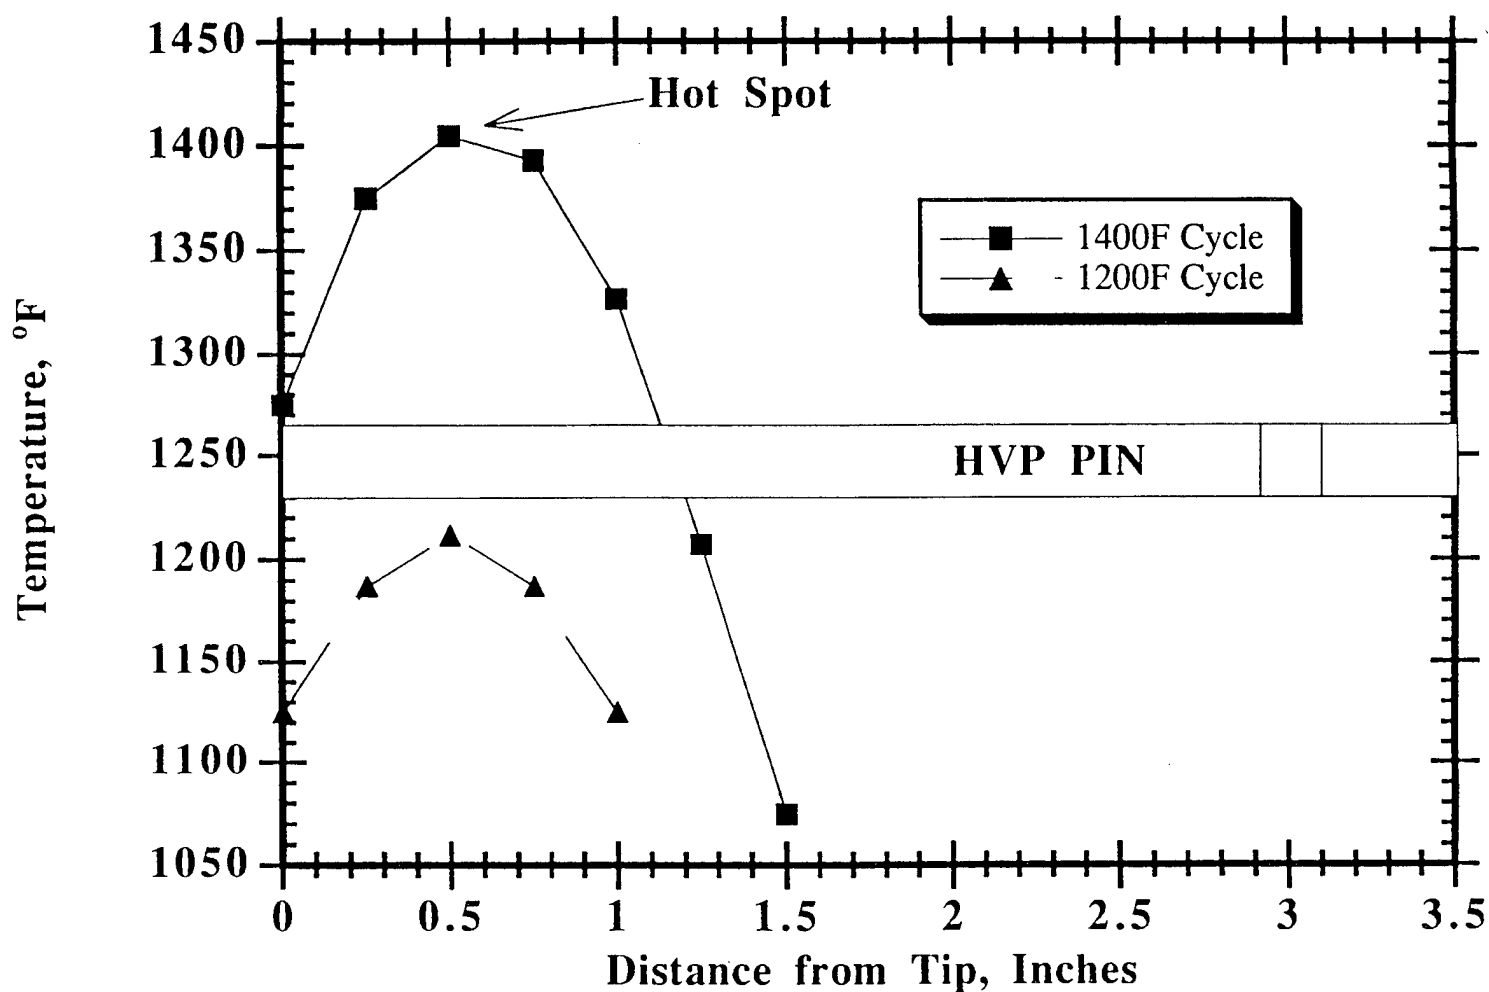
Figure 150. Graph showing the temperature profile of the pins during the 760/648°C burner rig test. Careful cross sectioning allows different conditions to be analyzed on the same pin.

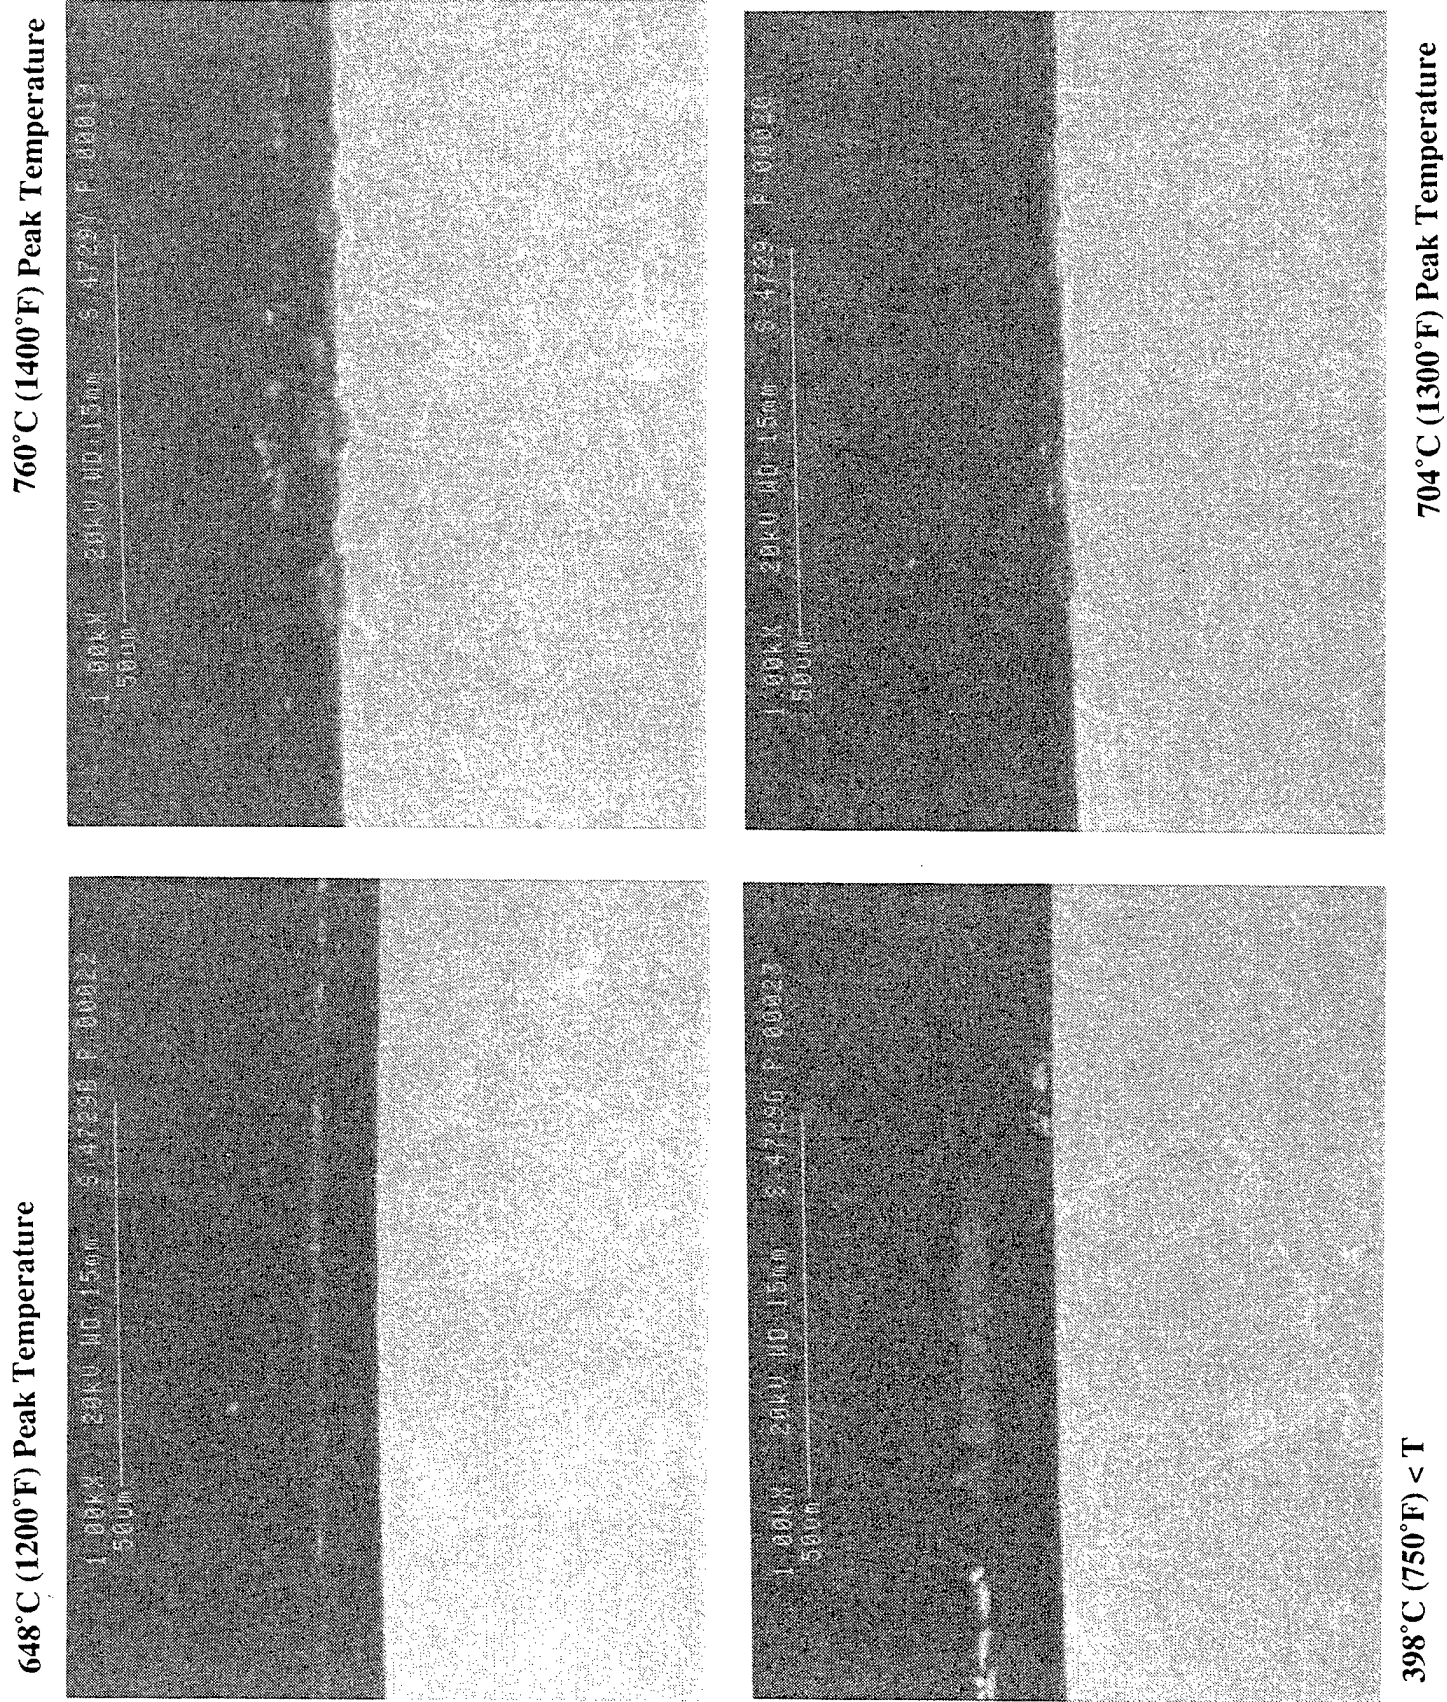
Figure 152. Micrographs showing cross sections of the Ti-48Al-2Cr-2Nb gamma alloy as a function of peak temperature attained during burner rig testing.
